# PROJECT SUMMARY

## Guaricayán : Potable Water System

January 2011 – March 2011

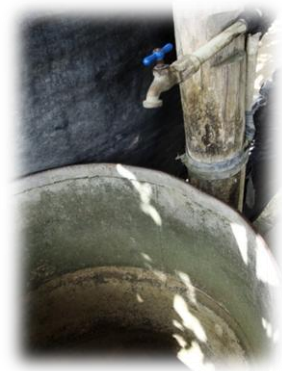
Water connection of previous system. Faucet was found open, but had been without water for eight days.

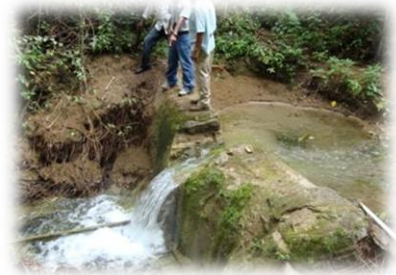
- The dam at the water source was a simple concrete wall and there were suspected losses due to the porous geology where dam floor and side walls had not been built.

Previously existing dam

the community to the dam site. In order to begin laying the foundation of the dam, the water from the stream was diverted to one side to maintain a relatively dry work site. A simple dam was built with a sealed concrete floor, side and front walls with a height of 80 centimeters, a spillway with a width of 80 centimeters, two 4-inch cleaning pipes, an intake structure, and an outlet valve.

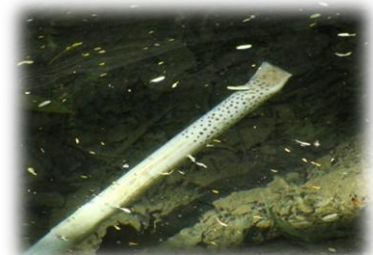
- The flow in the water source at the dam site was sufficient to provide water consistently to the population of Guaricayán.
- The intake structure at the dam was a simple 1" PVC pipe with small holes drilled in it, placed in the reservoir behind the dam and directly connected to the piping in the conduction line.

Intake structure of original system

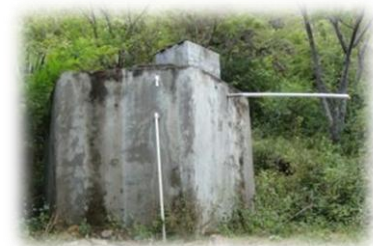
- The storage tank was poorly constructed, too small, and the chlorination system had been damaged and was not working.
- The community was not chlorinating due to the fact that their storage tank was empty for such long periods of time.

Original storage tank

A 5,000 gallon steel reinforced concrete storage tank was constructed. To create a level construction site the necessary groundwork was performed before the foundation could be laid. A chlorination tank was constructed on top of the storage tank so that the members of Guaricayán will be able to properly treat their water. All necessary valves and

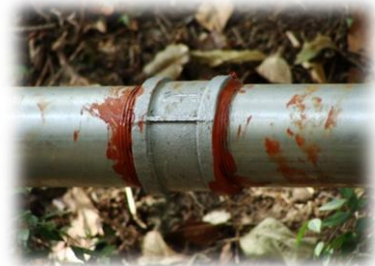
3" Galvanized iron pipe installed for the first 48 meters of conduction line

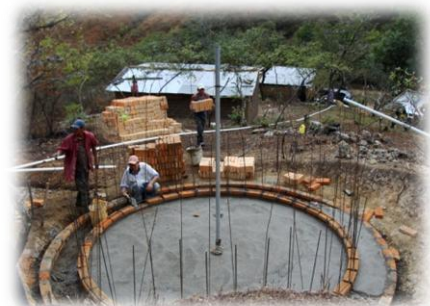
Construction of the new 5,000 gallon storage tank in Guaricayán

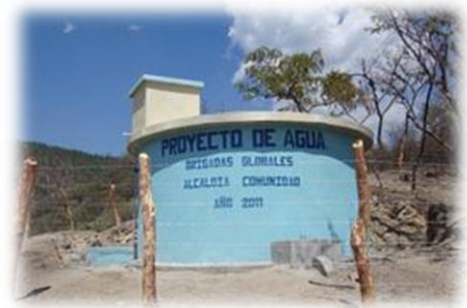
Finished storage tank in Guaricayán

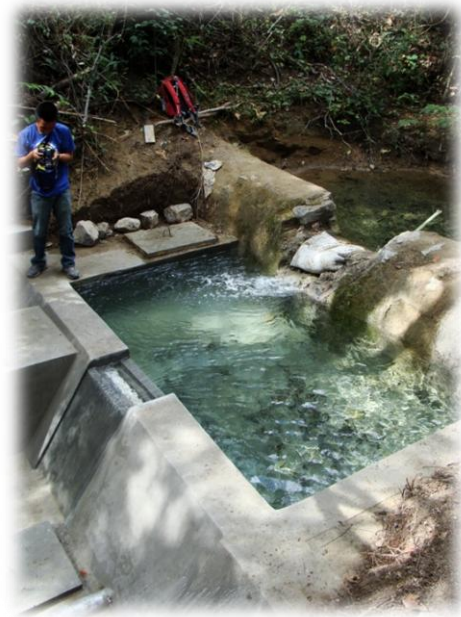
Finished and functioning dam of new system
