PROJECT SUMMARY

El Zurzular: Potable Water System

AUGUST 2009 – January 2010

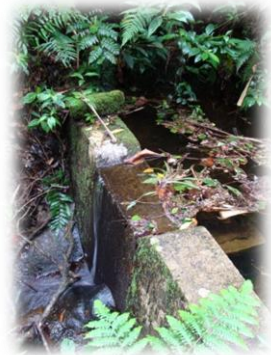
- Significant sediment levels in the small reservoir at the water source, storage tank, and at people's domestic connections was affecting water quality and quantity.

Original state of dam

Work at the water source began with draining and cleaning out all sediment that had built up in the reservoir over the years. A filter was then built and installed to filter out large particles (sand, pebbles, leaves, etc.). The filter design consisted of a network of 3" PVC pipe with slots cut into the underside of each pipe. The ends of all pipes were capped so that water could only enter through the underside of the pipe network. Sediment will settle on the bottom of the reservoir and not flow in an upward motion through the slots. Rocks of increasing size were placed on top of the PVC filter network to further promote filtration.

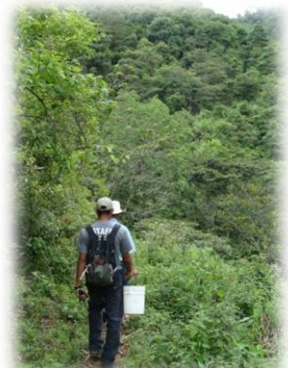
System diagnostic – July 2009

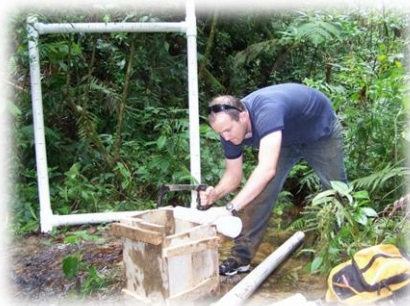
Filter construction

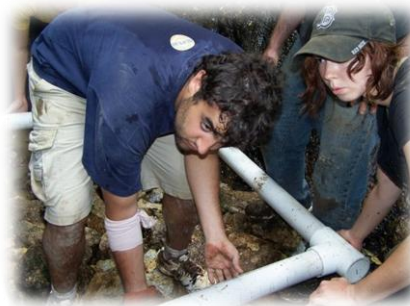
Filter installation

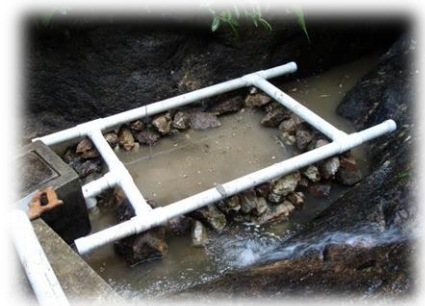
Finished, installed filter

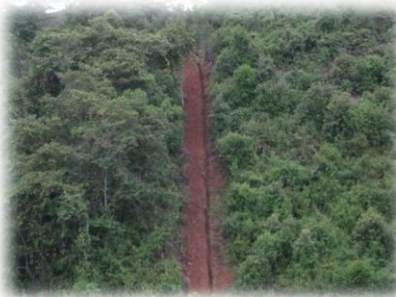
The conduction line was constructed of both PVC (plastic) and GI (Galvanized Iron) pipes. Wherever possible, trenches (60 – 100 cm deep x 30 cm wide) were dug in order to lay the relatively less expensive PVC pipe. On rocky terrain or for stream/gorge crossings GI pipe was installed. Over 3,600 meters of trench was dug by community members and student

Trench dug for conduction line

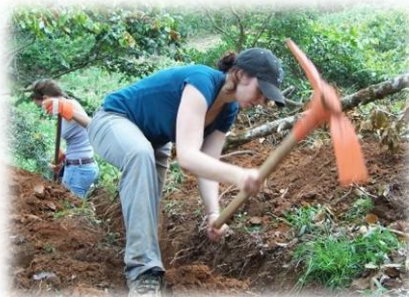
Students pickaxing trench for conduction line

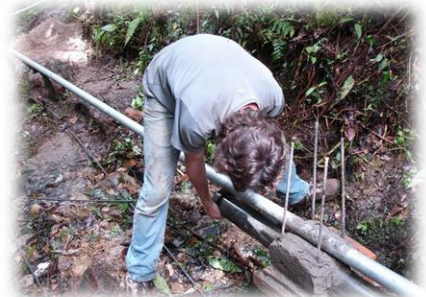
Installation of first lengths of GI pipe in the conduction line

volunteers. Students and community members installed 15 lengths (~6 m/length) of 2" GI pipe, 230 lengths of 2" PVC pipe, and 365 lengths of 1 ½" PVC pipe to complete the over 3,700 meter conduction line.

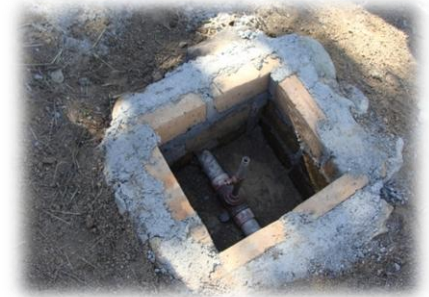
- 1 Outlet valve: allows the quantity of water leaving the reservoir and entering the conduction line to be controlled.
- 4 Cleaning valves: installed at low points of the conduction line, these valves allow for any sediment that does manage to get into the pipeline to be flushed out.
- 4 Air valves: installed at high points of the conduction line, these valves allow for any air that has built up in the pipeline to be released.
- 1 Inlet valve: allows for the quantity of water entering the storage tank to be controlled.

One of four air valves with valve box

A covered valve box was constructed for each valve for protection of the valve and security.

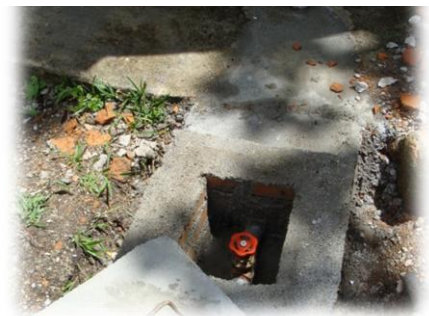
Inlet valve to storage tank with valve box

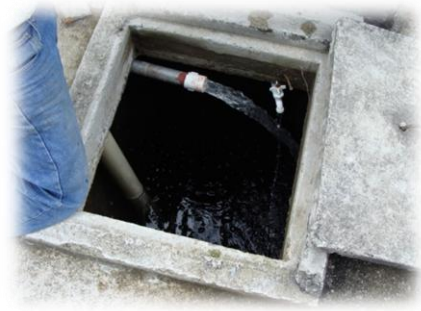
Water successfully reached the tank without any leaks in the pipeline. A new flow rate of 38 gpm was achieved. The chlorination tank was tested and no leaks were detected. A consistent chlorination drip rate was achieved.

38 GPM entering tank through new conduction line

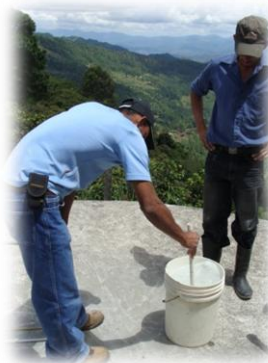
Plumber being trained on chlorination process

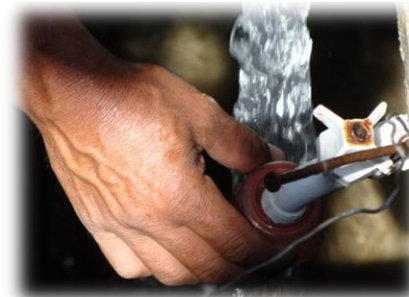
Measuring chlorine drip rate

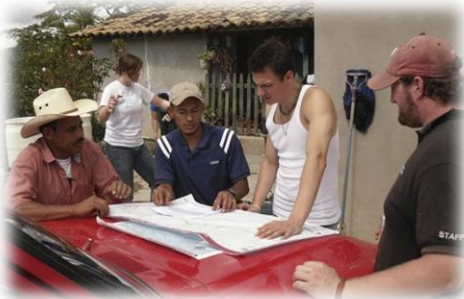
Reviewing distribution system plan with student volunteers

All piping from the existing distribution network was replaced. The design of the distribution network was changed where necessary, and new branches were installed to ensure that water arrived consistently to all domestic connections. Over 3,000 meters of trench was dug by student volunteers and community members. PVC and GI pipe of the following diameters was installed: 3", 2", 1 ½", 1" and ½". Control valves and valve boxes were installed where determined necessary for the proper control and operation of the system.

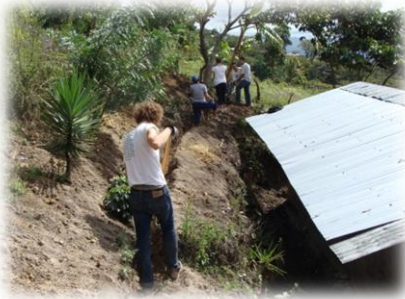
DePaul University students dig trenches for installation of new distribution network

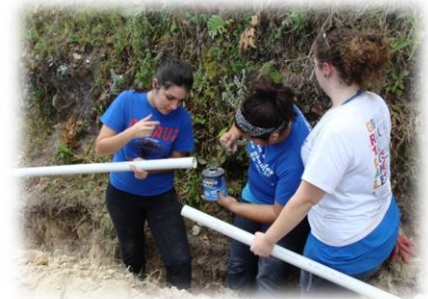
Distribution network pipes being glued together

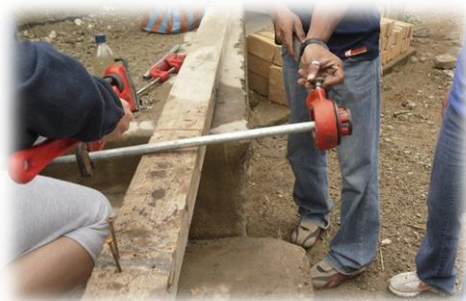
New household connections were fabricated using GI pipe and faucets. Connections were installed in all houses without a previous connection. In addition, houses with non-functioning or deteriorated connections also receive new connections. Once completed, 100% of the houses in El Zurzular were connected to the water system.

Fabrication of household connection:
Pipe being threaded

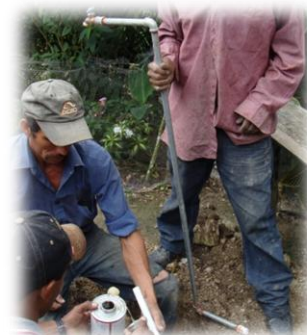
Installation of a new household connection

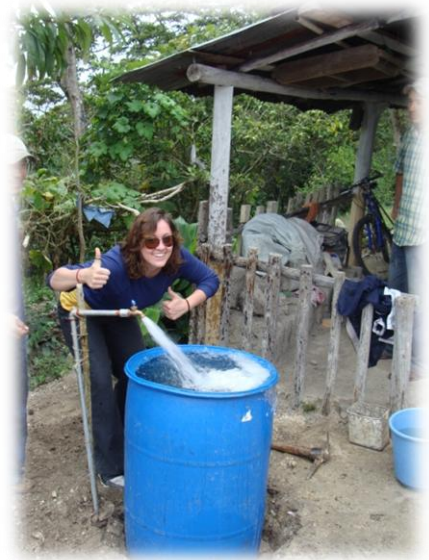
Water connection turned on for the first time at house in El Zurzular
