PROJECT SUMMARY

El Encinal: Potable Water System

August 2009 – June 2010

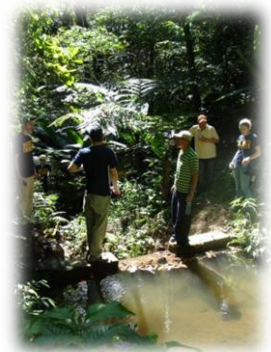
- The system was 25 years old and was only serving a portion of the homes in the community. Houses without water connections were either without water, were gathering water from streams or other sources, or were getting water from their neighbors when possible.
- The dam at the water source was a simple concrete wall and there were suspected losses due to the porous geology where dam side walls had not been built.
- During the rainy season sediment loads in the water source caused problems with the intake structure at the dam. The lack of cleaning and air valves in the conduction line prevented the community from being able to properly clean and maintain the system causing sediment to collect in the piping.

Visiting the dam as part of the system diagnostic

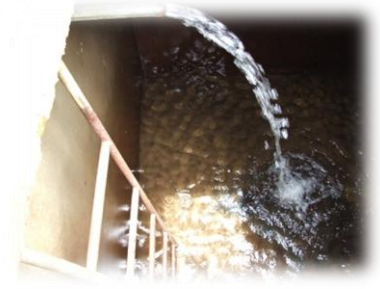
- Flow entering the storage tank was measured as under 12 gallons/minute (gpm), less than half of the flow necessary to provide all 80 houses in El Encinal and El Junco with the recommended minimum of 25 gallons/person/day.

12 gpm entering the original storage tank in El Encinal

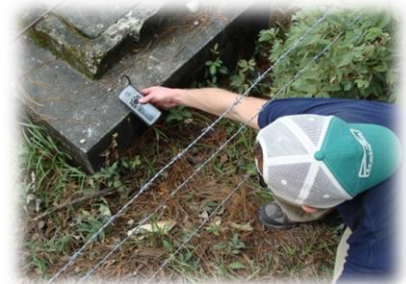
Taking a GPS reading at an existing pressure break tank

- A preliminary GPS study was performed to identify a potential new storage tank site and conduction line route.
- A detailed study of the previously existing distribution network was performed with the support of community members where all houses were visited and mapped.

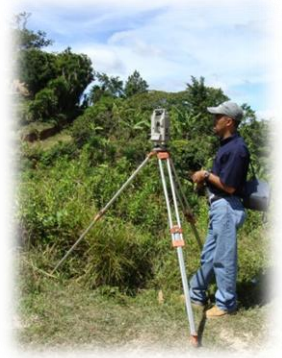
- A topographical study was performed to:
 - Verify the new storage tank location and elevation. It was ensured that it was below the dam site and above the eight houses which were previously not served by the system due to their elevation.

- Design the exact route of the conduction line to the new storage tank site.
 - Design the new distribution network including all previously unconnected houses.

- Using the topographical study, the conduction line and distribution network were designed by student volunteers from Marquette University.
- All new pipelines were measured to determine the amount of piping, glue, valves, accessories, and other materials that needed to be purchased to complete the reconstruction.

Topographical study in El Encinal

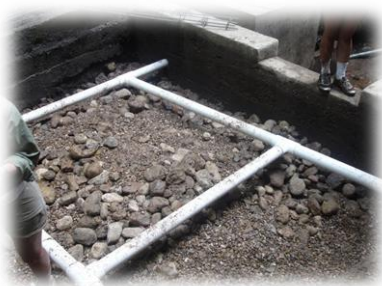
PVC filter installed at the dam site

Work at the water source began with removing all sediment that had built up in the dam reservoir and system intake structure. While the site was prepared for construction, community members carried all cement, sand, rocks, gravel, rebar, and necessary tools from the community to the dam site. Concrete walls were built and a simple PVC, rock, and gravel filter was installed and connected to the intake structure to lower sediment loads in the system.

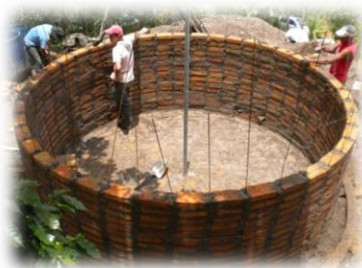
Construction of the new storage tank

A 5,000 gallon steel reinforced concrete storage tank was constructed. To create a level construction site the necessary groundwork was performed before the foundation could be laid. A chlorination tank was constructed on top of the storage tank so that the members of El Encinal will be able to properly treat their water. All necessary valves and connections were installed including: inlet valve, outlet valve, cleaning valve, and overflow pipe.

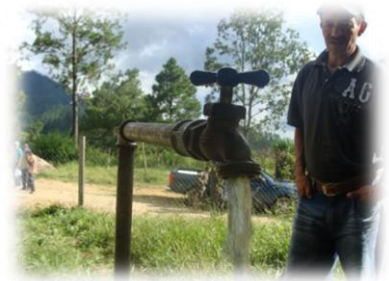
Water turned on for the first time in the new system at the El Encinal school
