# PROJECT SUMMARY

## Guaricayán : Potable Water System

January 2011 – March 2011

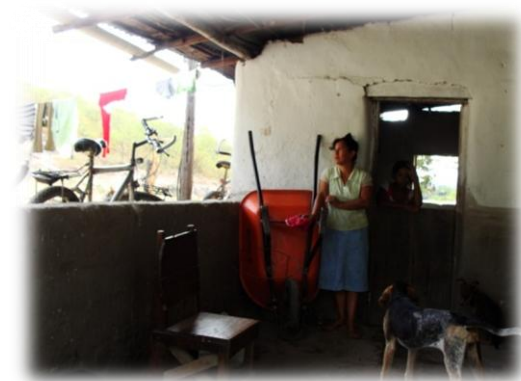
Liana Lopez who lives in the higher part of Guaricayán rarely received water from the old system

- Houses in the higher areas of the communities were rarely receiving water due to lack of flow rate entering the tank and poor distribution network design.

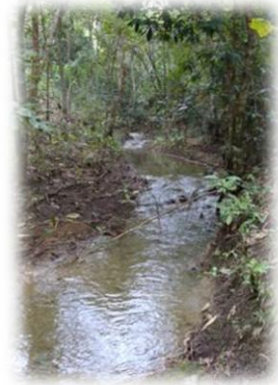
Water source in Guaricayán

- The flow in the water source at the dam site was sufficient to provide water consistently to the population of Guaricayán.
- The intake structure at the dam was a simple 1" PVC pipe with small holes drilled in it, placed in the reservoir behind the dam and directly connected to the piping in the conduction line.

- Water quality testing was performed at the water source. It was determined that the water was safe for human consumption if properly treated. The water had high hardness levels which do not, however, present any threat to human health.

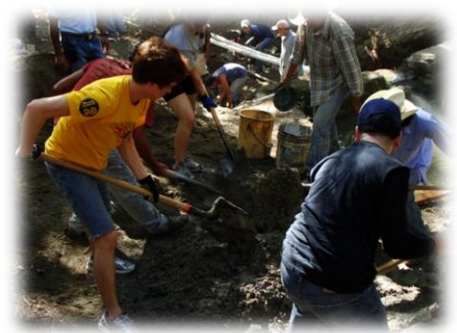
Student volunteers work with community members on construction of new dam

the community to the dam site. In order to begin laying the foundation of the dam, the water from the stream was diverted to one side to maintain a relatively dry work site. A simple dam was built with a sealed concrete floor, side and front walls with a height of 80 centimeters, a spillway with a width of 80 centimeters, two 4-inch cleaning pipes, an intake structure, and an outlet valve.

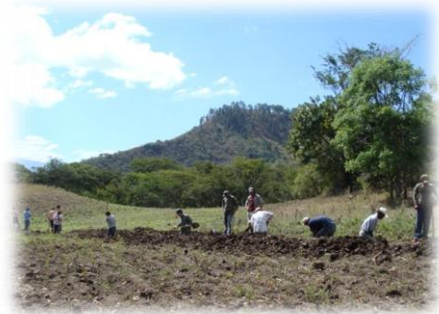
Student volunteers dig trenches with community members where they would later install piping for the new conduction line

The conduction line was constructed of both PVC (plastic) and GI (Galvanized Iron) pipes. Wherever possible, trenches (60 – 100 cm deep x 30 cm wide) were dug in order to lay the relatively less expensive PVC pipe. Students and community members installed 48 meters of 3" GI pipe in the conduction line. Concrete anchors were constructed to sustain the GI portion of the piping. Over 800 meters of trench were dug by community members and student volunteers. Where trenches began, 3" and 2" PVC pipe was installed until reaching the site of the new storage tank.

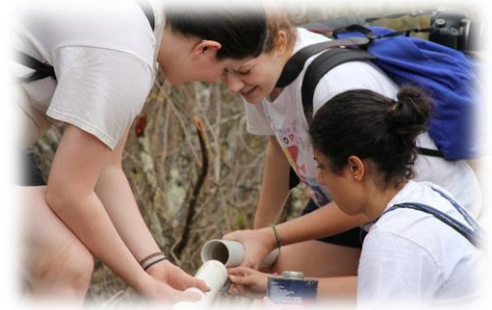
Student volunteers installing PVC piping in the distribution network

All piping from the existing distribution network was replaced. The design of the distribution network was changed where necessary, and new branches were installed to ensure that water arrived consistently to all sectors and domestic connections. Over 2,800 meters of trench were dug by student volunteers and community members. PVC and GI pipe of the following diameters was installed: 2", 1 ½", 1" and ½". Control valves and valve boxes were installed where determined necessary for the proper control and operation of the system.

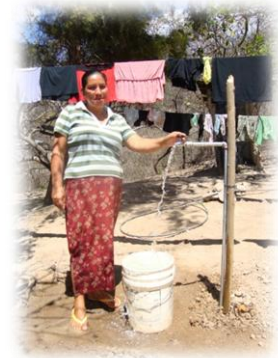
Woman in Guaricayán testing her new water connection for the first time

New household connections were fabricated using GI pipe and faucets. Connections were installed in all houses including those without a previous connection. Once completed, 100% of the houses in Guaricayán were connected to the water system.
