WATER BRIGADES PROJECT FOLLOW UP: EL ENCINAL, JOYAS DEL CARBALLO

DATE OF FOLLOW UP VISIT: 6 September 2012

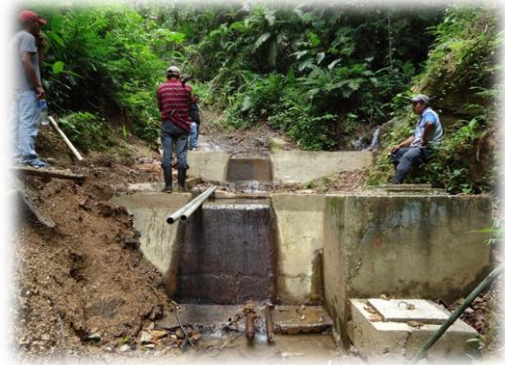
Community leaders show the changes made at the dam to Water Brigades staff.

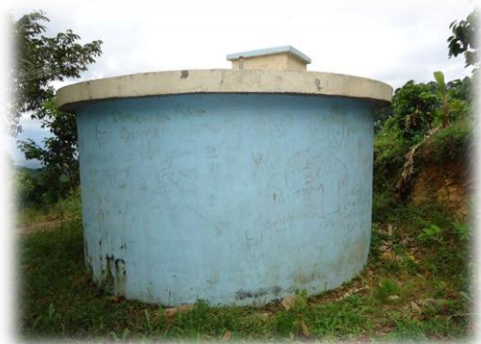
While Global Brigades visits were suspended due to security concerns, a strong tropical storm hit the mountain of Joyas del Carballo in October 2011 causing flooding and massive landslides. The El Encinal water system remained mostly intact, but the storm damaged several sections of pipe in the conduction line and the storage tank. In May 2012, FORCUENCAS, an institution funded by the European Union, donated the money to El Encinal to replace the damaged piping. An additional structure at the source was built to improve the water intake structure at the existing dam. The rest of the piping in the conduction line and all of the piping in the distribution network was unharmed. The storage tank functions well, although a small leak was found in the foundation,

Central storage and treatment tank in El Encinal still functions well but needs a protective fence and some foundational repairs.

most likely caused by the land movements from the storm. Families reported that when the system was initially repaired it was less dependable and the water often came out of the faucets dirty; the quality of the water has since improved and arrives consistently.

Water Brigades staff met with the Water Council and some additional members of the community and discussed all aspects of the system, including the importance of improving maintenance on the system and centrally chlorinating the water at the tank. Water Brigades staff strongly advised the community to meet and reform the Water Council to create a complete, 7-member council. It was additionally discussed that with the reformation of the Water Council, the community needs to support the new council and begin paying their monthly water fee so that they can purchase chlorine, properly maintain and administer the system, and pay the plumber for his work. It was also recommended for the Water Council to repair the tank and fence it in for added security.

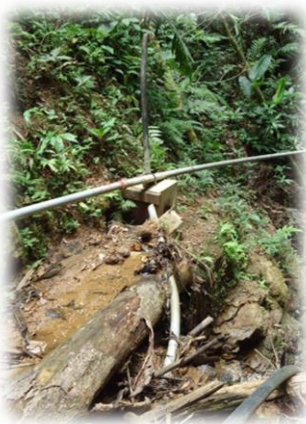
A cement anchor stabilizes the new piping in the conduction line donated by FORCUENCAS. The former piping installed by Water Brigades was bent by the force of the storm and can be seen in the lower front of the picture partially covered by debris.
